TECHNICAL NOTE

# A technique to remove a well-fixed titanium-coated RM acetabular cup in revision hip arthroplasty

Fernando MJ Judas\*, Rui F Dias and Francisco M Lucas

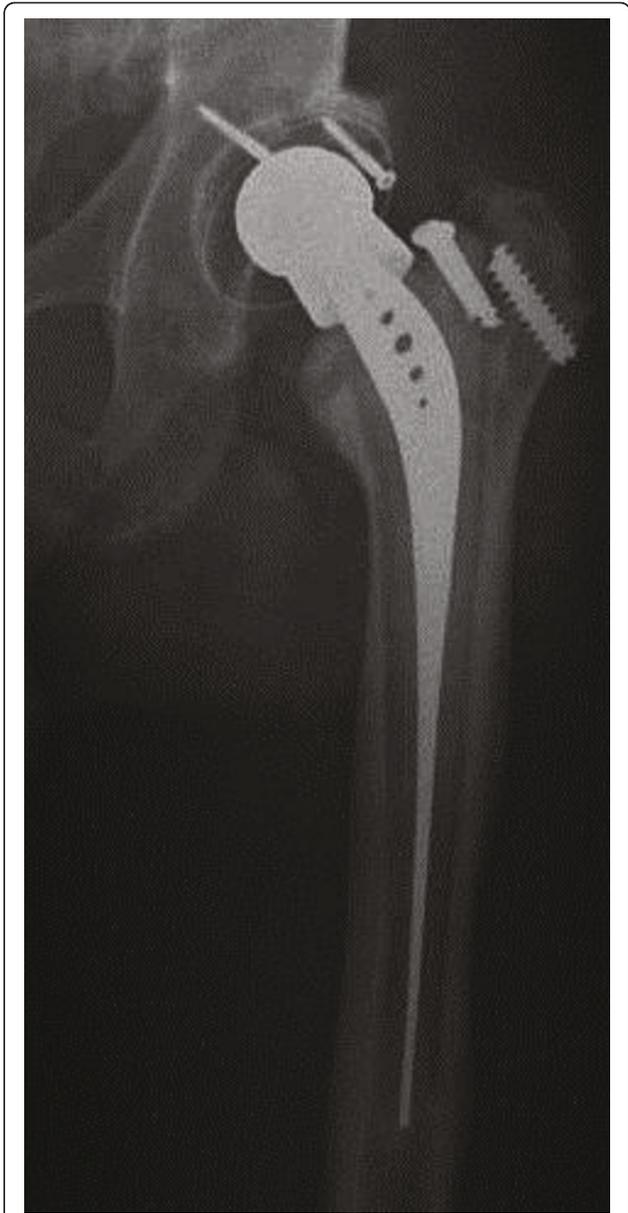
**Figure 1** Twenty years after primary hip arthroplasty. The radiograph shows loosening of the isoelastic cementless femoral stem and well-fixed titanium-coated RM acetabular cup.

A 75-years-old man presented a bilateral hip arthroplasty. The clinic and the radiograph showed aseptic loosening of an cementless prosthesis in the left side, with 20 years of follow-up. The polyethylene titanium-coated RM acetabular cup was well-positioned and well-fixed, and no radiolucent lines are present in the bone/implant interface. The isoelastic femoral stem showed a mechanical instability, the two screws of stem being broken (Figure 1).

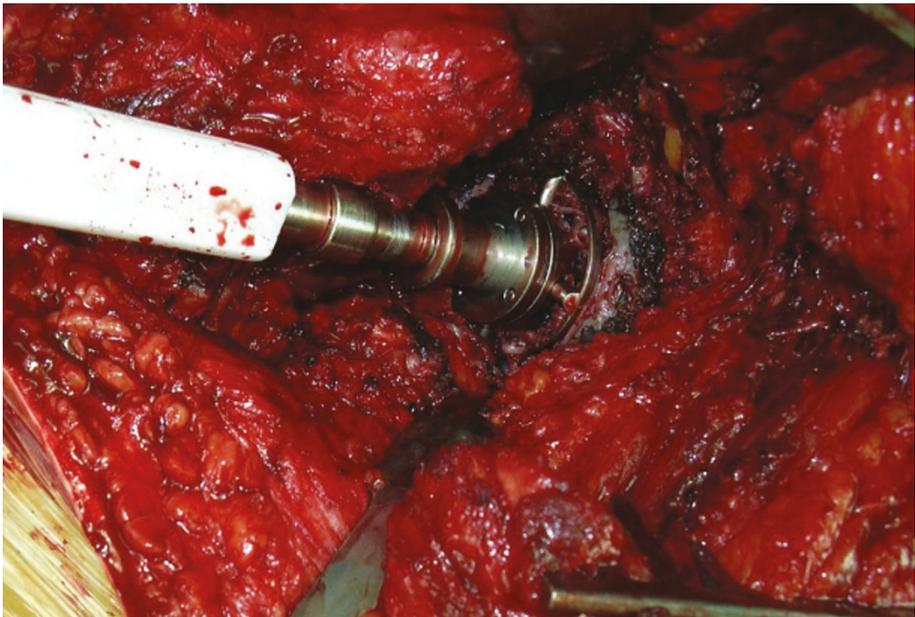
**Figure 2** Reaming of the center of the cup with powered acetabular reamers.

The first reamer was a small standard-powered *cheese grater* acetabular reamer (40 or 44 mm). It was placed in the middle of the inner part of the cup (Figure 2). Reamers of increasing sizes are used successively to wear the polyethylene layer (Figure 3). A minimal amount of polyethylene debris ("polyethylene chips") was removed of the articular soft tissues to avoid any biological reaction.

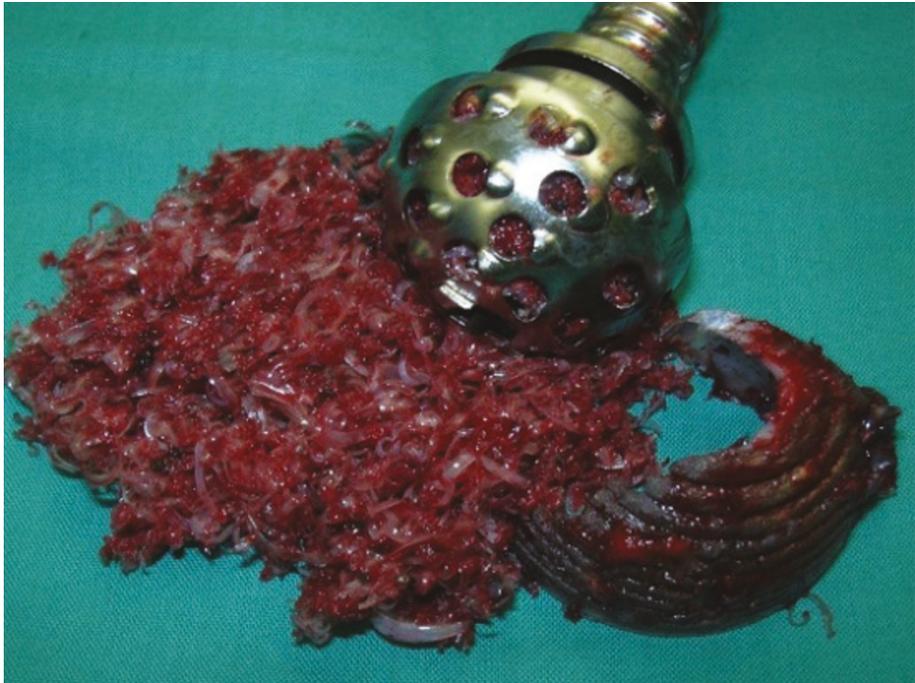
**Figure 3** When the polyethylene layer was thin enough, the remaining cup was removed easily by hand tools and bone stock is preserved.

In this case, we used chisels to weak the superior part of the implant and to create a roughness surface for the reamer action. When the polyethylene was thin enough, it was removed easily by hand tools without the risks of

bone fractures and bone stock loss. This technique is not time-consuming. The duration of the procedure was 12 minutes.

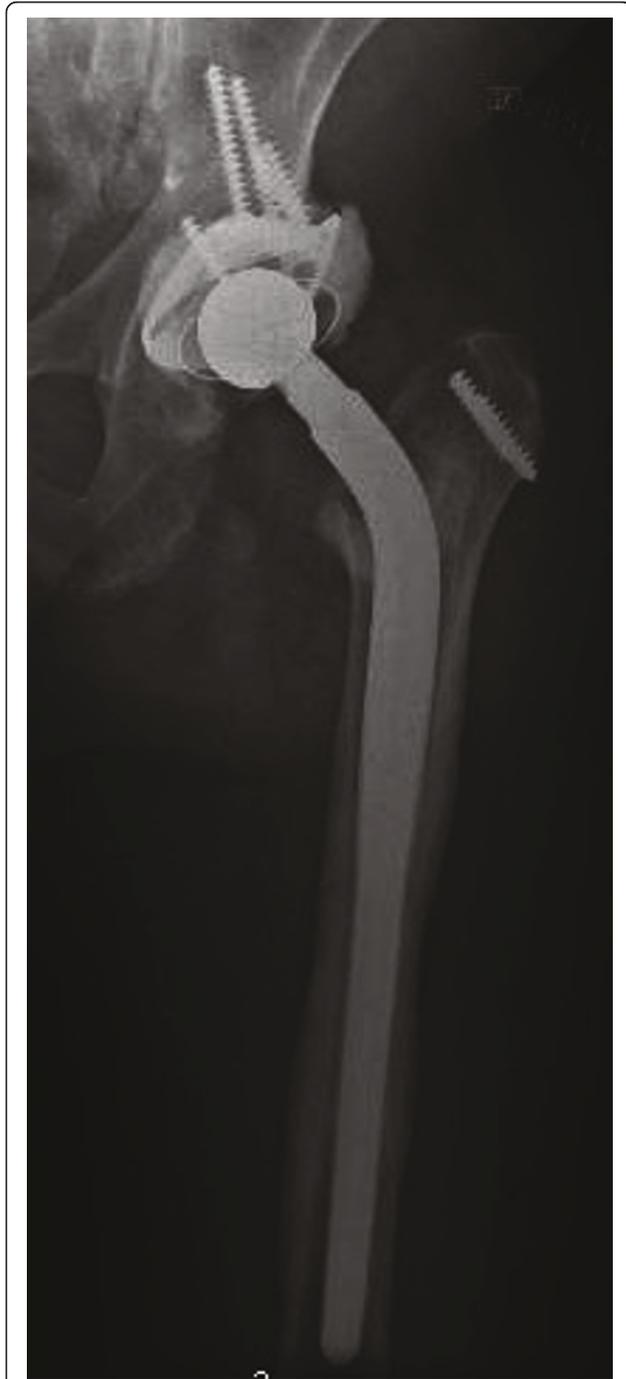
**Figure 4** Hip reconstruction with a metallic reinforcement ring and a conical cementless stem, without acetabular bone loss. Cancellous bone allograft was used in the femoral side.

A metallic support ring and a cemented polyethylene cup were implanted. The femur was reconstructed with a revision conical stem and using morselized

cancellous bone allograft cryopreserved [9-11]. The bone allograft was impacted to fill the space between the proximal part of the implant and the cortical native bone (Figure 4).
